STORM DATA EXCERPT FOR HURRICANE ANDREW - AUGUST 1992

Damage Survey of Hurricane Andrew in South Florida by Ted Fujita

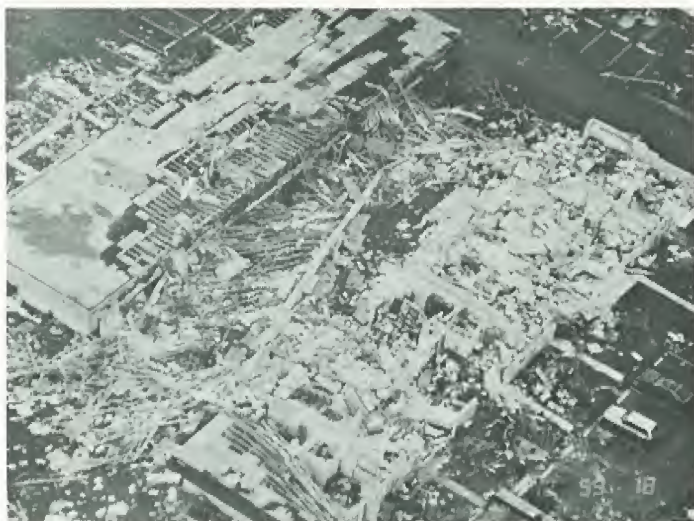
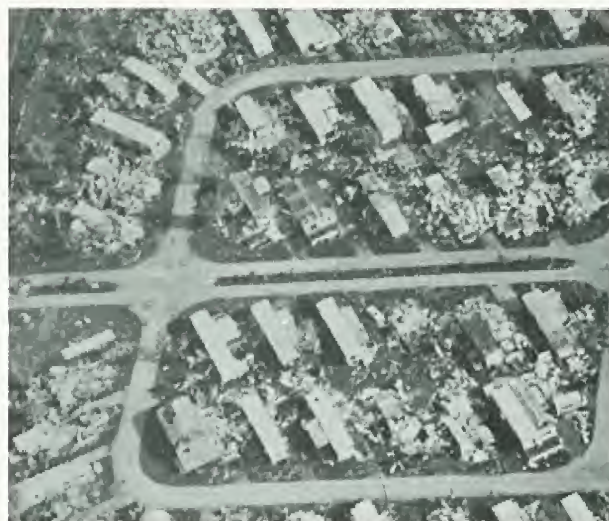
Left: A Naranja Lakes condo oriented in the wind-perpendicular (broadside) direction. The roof was lifted into a vertical position and dropped upside-down after a 180° rotation. Connected and broken tie-beams weighing one ton per 20 ft are visible on the downwind side. Fujita photo 1253 EDT 9/14/92. **Right:** Mobile homes at Naranja Lake oriented by luck in the wind-parallel (streamline) direction. Fujita photo 0906 EDT 9/8/92.

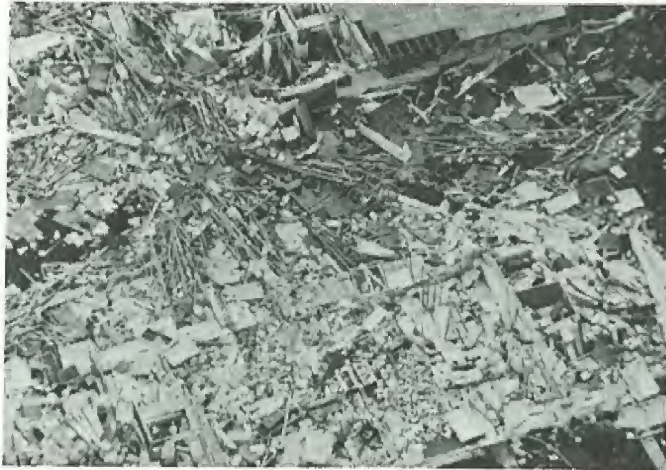
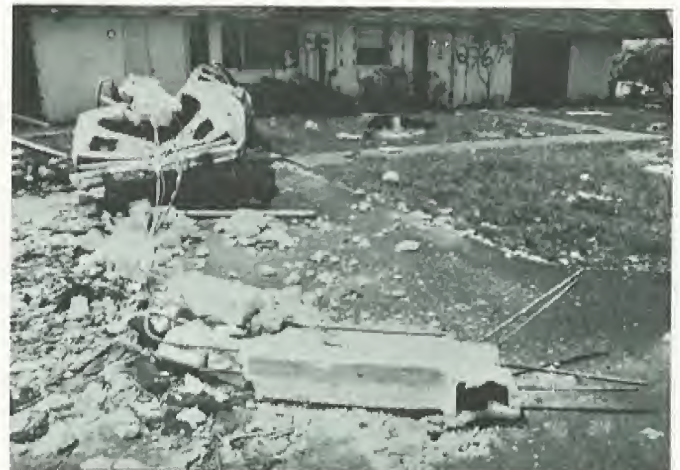
Left: An f3 damage of Naranja Lakes condo caused by a mini-swirl that formed inside the second wind. Fujita photo 1253 EDT 9/14/92. **Right:** Pieces of a connected tie-beam which flew 150 feet (45m) from a Naranja Lakes condo in the second wind. Fujita photo 1246 EDT 9/10/92.

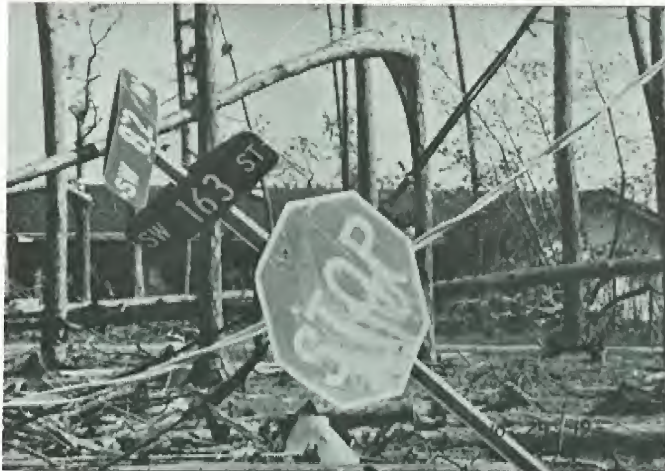
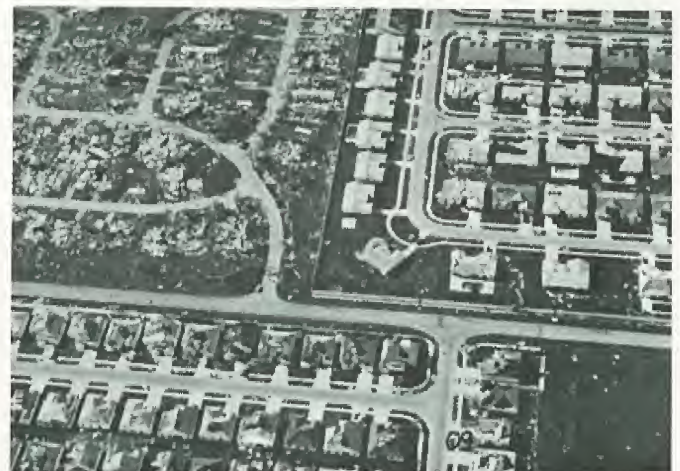
Left: A confusing stop sign at 82 Ave and 163 St SW in Cutler located near the north edge of the Tamiami Swath. Fujita photo 1024 EDT 9/16/92. **Right:** Triple junction of f-scale damages. An f4 damage at a trailer park (upper left), f2 at the lower-left subdivision, and f0 to f2 at the upper right subdivision. Relatively uniform peak winds (F-scale winds) expected at the junction caused a wide range of f-scale damages between f0 and f4. Fujita photos 0945 EDT 9/8/92. **Note that the Fujita Scales, now applied to both tornadoes and hurricanes, refer to the Fujita Wind Speed scale (F scale) and Damage scale (f scale),** because an F-scale wind would cause different f-scale damages to different types of structures. See examples.

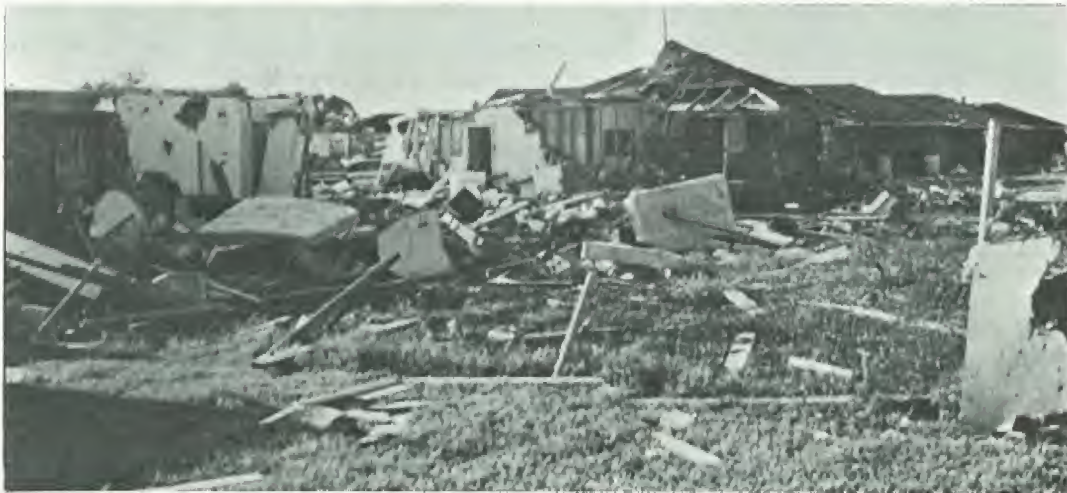
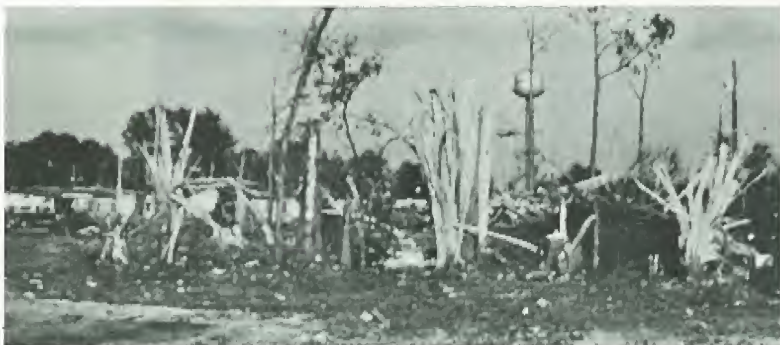
Above: Additional view of the damage in La Place. A total of 122 homes, 32 mobile homes, and 25 business were damaged or destroyed. **Left:** These Ironwood trees were literally snapped off and splintered by the force of the tornado. *(Photo courtesy: NOAA DST)*

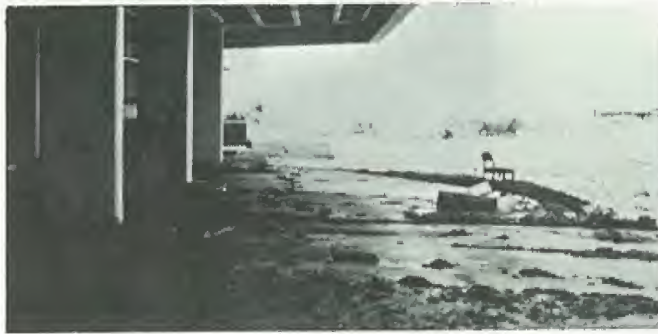
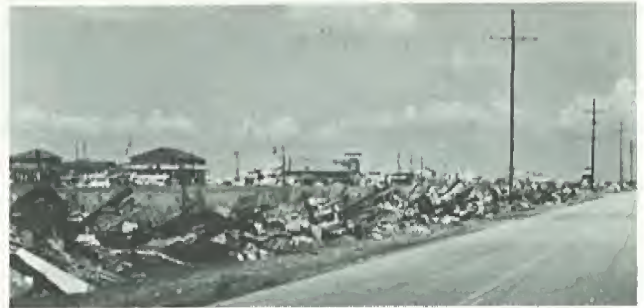
Left: The Louisiana Universities Marine Consortium (LUMCON) experienced a tidal surge of 5 to 7 feet. Note the silt and mud deposited by the storm surge. **Right:** The debris along Parish Highway 57, between the Cocodrie Petroleum Depot and LUMCON, was also left by the storm surge. Part of the debris had been originally strewn across the road surface before being cleared by highway crews. (Photo courtesy: NOAA DST)

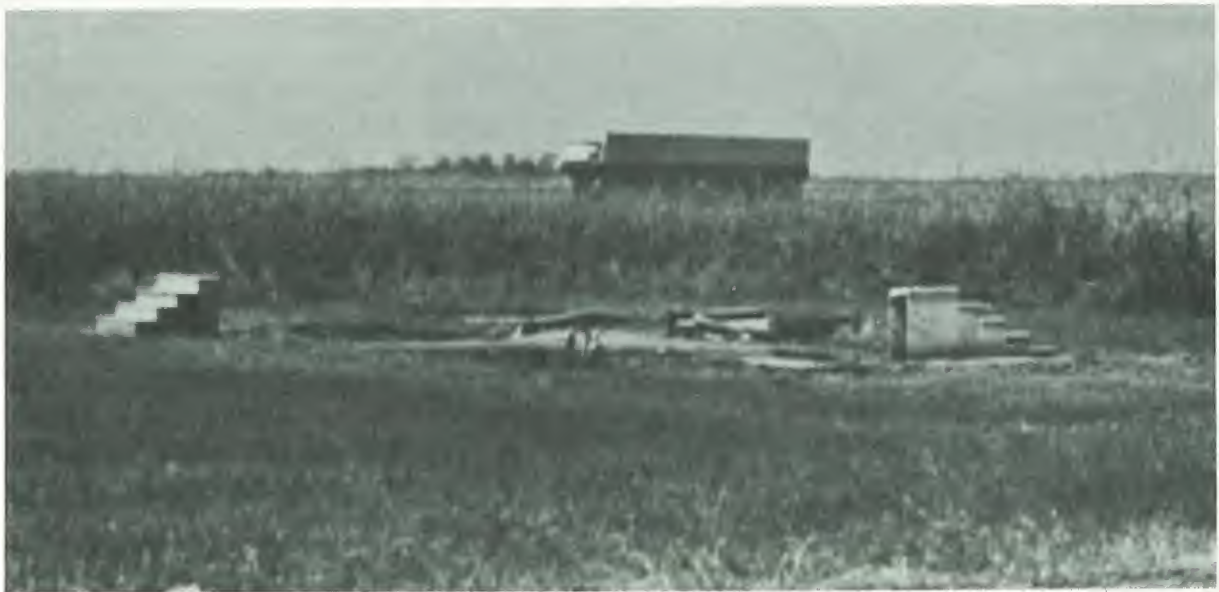
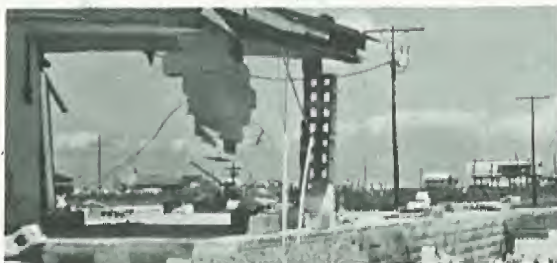
Above: This photograph was taken several miles north of the Cocodrie Petroleum Depot. Notice the steps that once provided access to the house. The combined effects of the storm surge and wind pushed the structure from its foundations and deposited it in the marsh. The roof in the center background is the only portion of the house that is still visible. **Left:** Another view of the damage caused by the likely combination of wind and storm surge. (Photo courtesy: NOAA DST)

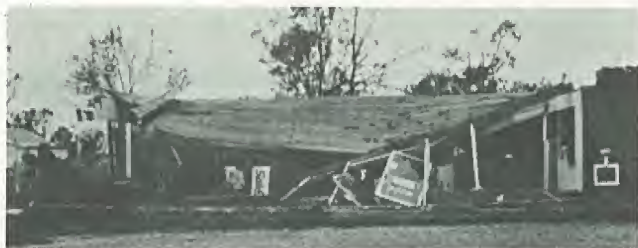
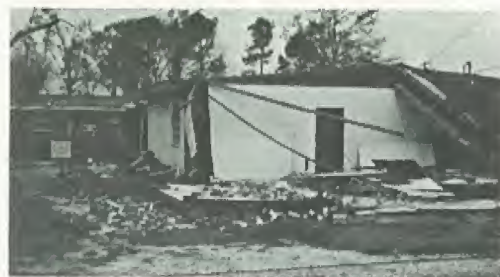
Top(left): This grocery store located on the outskirts of Jenerette typifies the type of damage sustained by many structures across south Louisiana. Top(right): The remnants of a small church along Route 182 near Franklin, Louisiana. Above: Mobile home located along one of the many inlets and channels south of Dulac that did not fare well in Andrew's fury. Left: Remnants of a twisted and tangled radio tower, north of Garden City along U.S. Highway 90. Bottom(left and right): Numerous large trees were uprooted and fallen on houses along Parish Road 329, north of Avery. Fortunately, the residents were not at home when the trees fell. (Photo courtesy: NOAA DST)
